PERFORMANCE TEST REPORT SUMMARY

Report No: 81239.01-106-31
ASTM C 67-07a

Product: NeaCera® Terra-cotta Wall Panels

Project Summary: Architectural Testing, Inc. was contracted by Avenere Cladding LLC to evaluate their NeaCera terra-cotta wall tile. The product description, test procedures, and test results are reported herein.

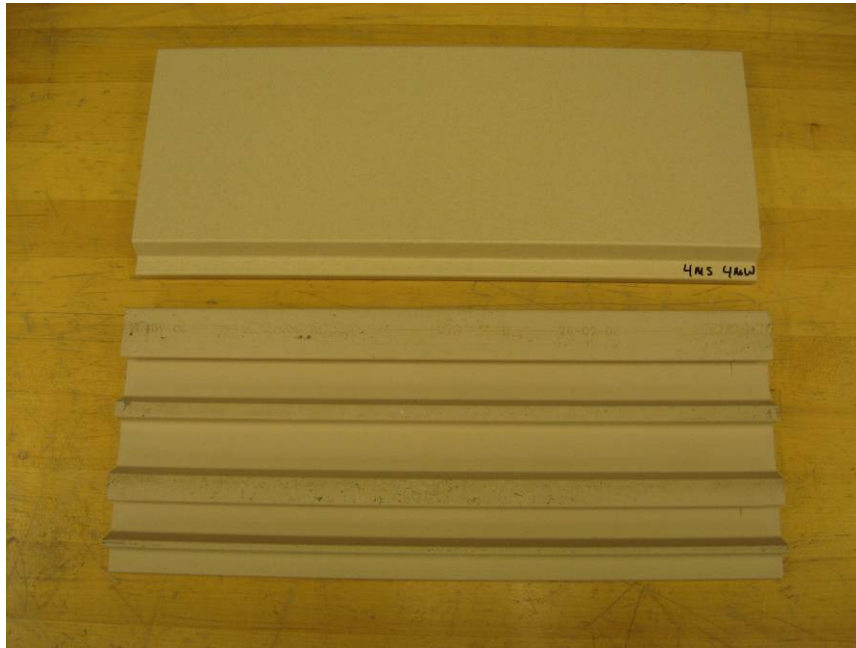
Photo No. 1
NeaCera® Terra-cotta Wall Tiles
As-received Pictorial Representation

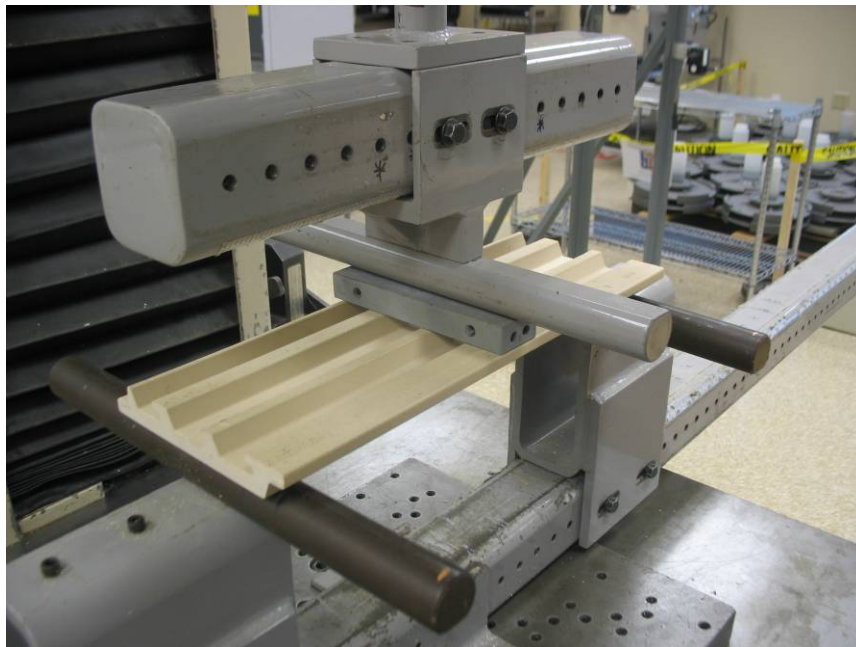
Photo No. 2
Modulus of Rupture
Typical Set Up of Test

Photo No. 2 in Appendix A shows a typical set up of the test, and Photo No. 3 shows the planes of failure.

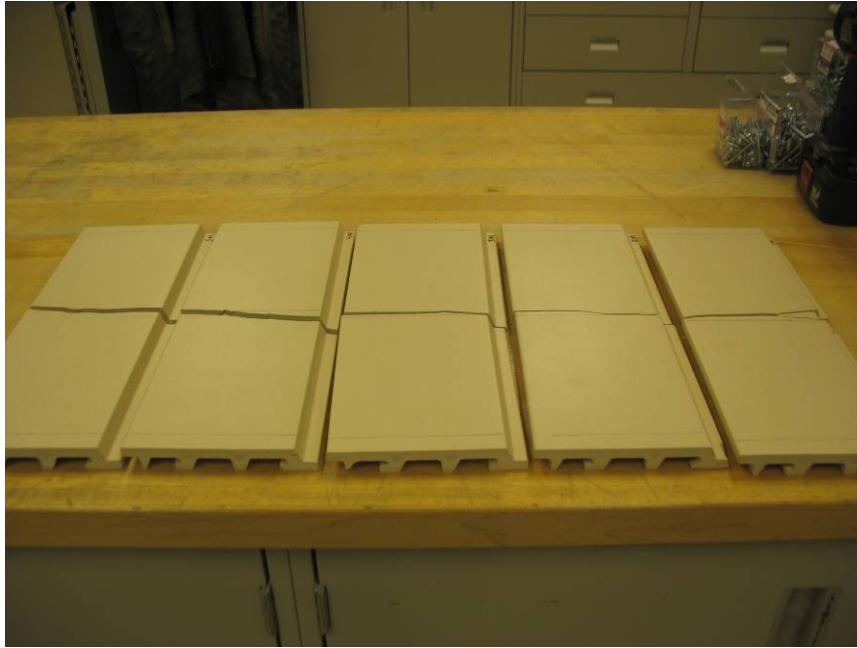
Photo No. 3
Modulus of Rupture
Planes of Failure

Modulus of Rupture at Plane of Failure (lb/in²)
Average: 2869

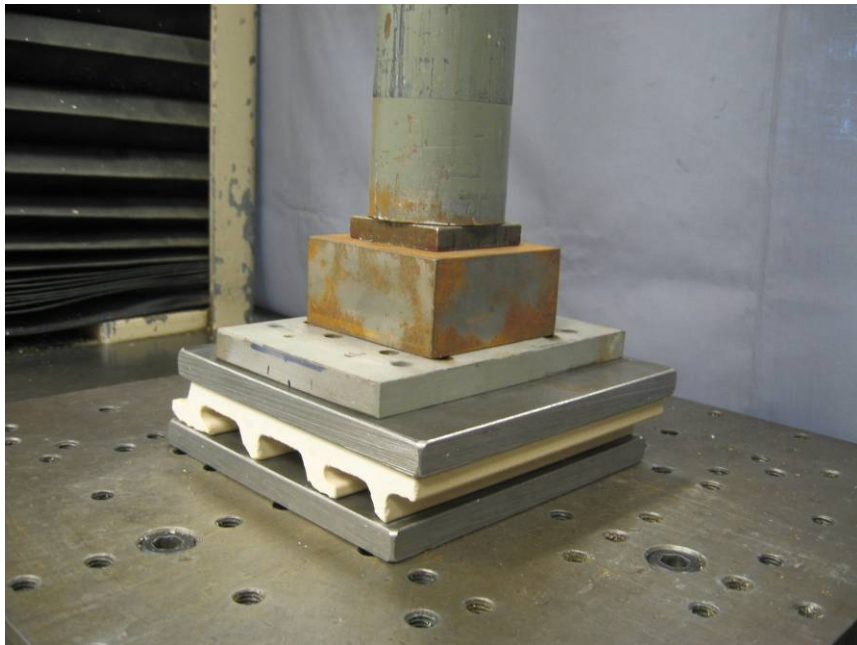
Photo No. 4
Compressive Strength
Typical Set Up of Test

Photo No. 4 in Appendix A shows a typical set up of the test, and Photo Nos. 5 and 6 show a test specimen after the test.

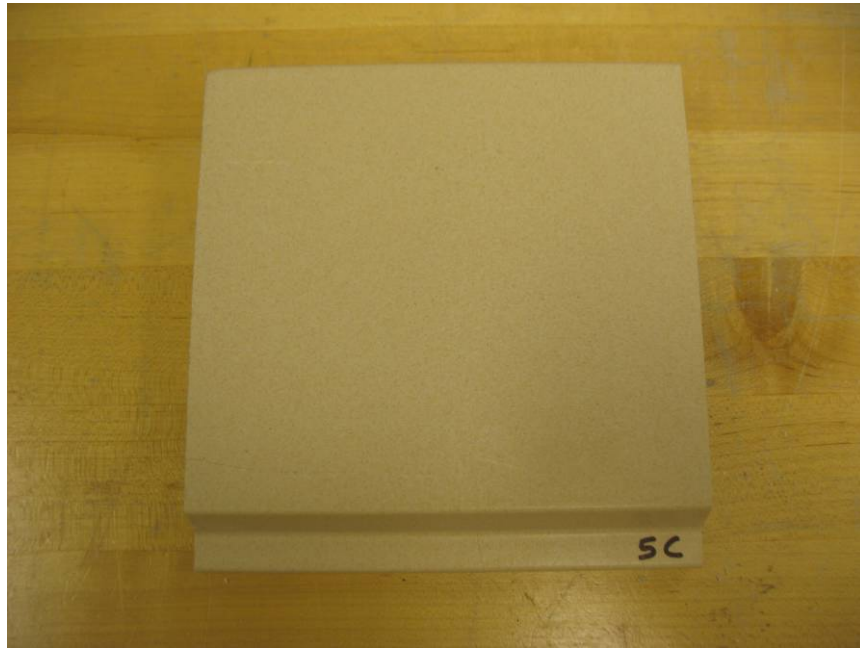
Photo No. 5
Compressive Strength
Test Specimen After Test

Maximum Load* (lb)	Minimum Compressive Strength (lb/in²)
50021	Average: 2133

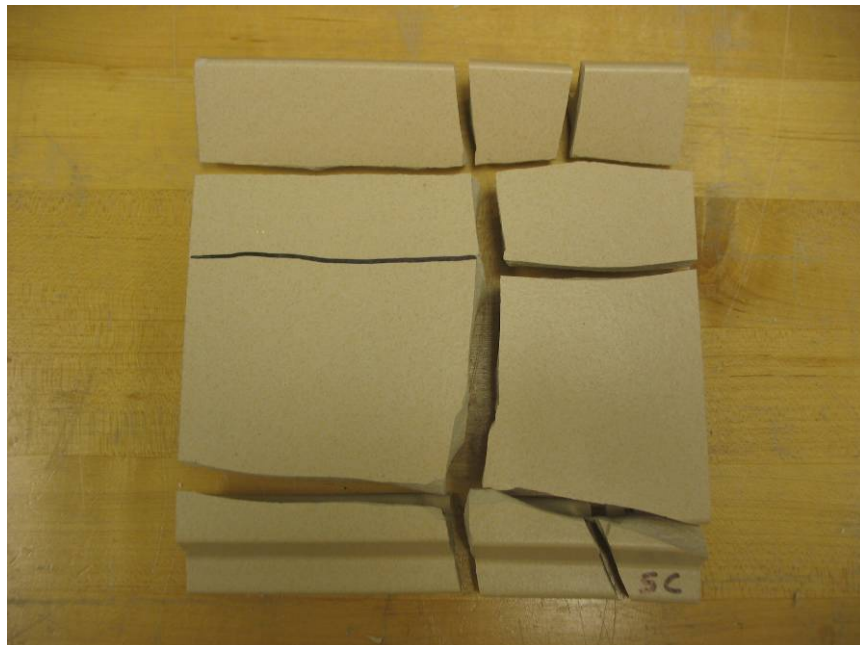
Photo No. 6
Compressive Strength
Same Test Specimen Separated at Cracks
