**Altech Panel System/
Mitsubishi Chemical America Alpolc Material**

STRUCTURAL PERFORMANCE TEST

NCTL-210-3064-1

NCTL Report No: 210-3064-1
TEST DATE: 11/22/04
REPORT DATE: 01/11/05
REVISION DATE: 05/11/09

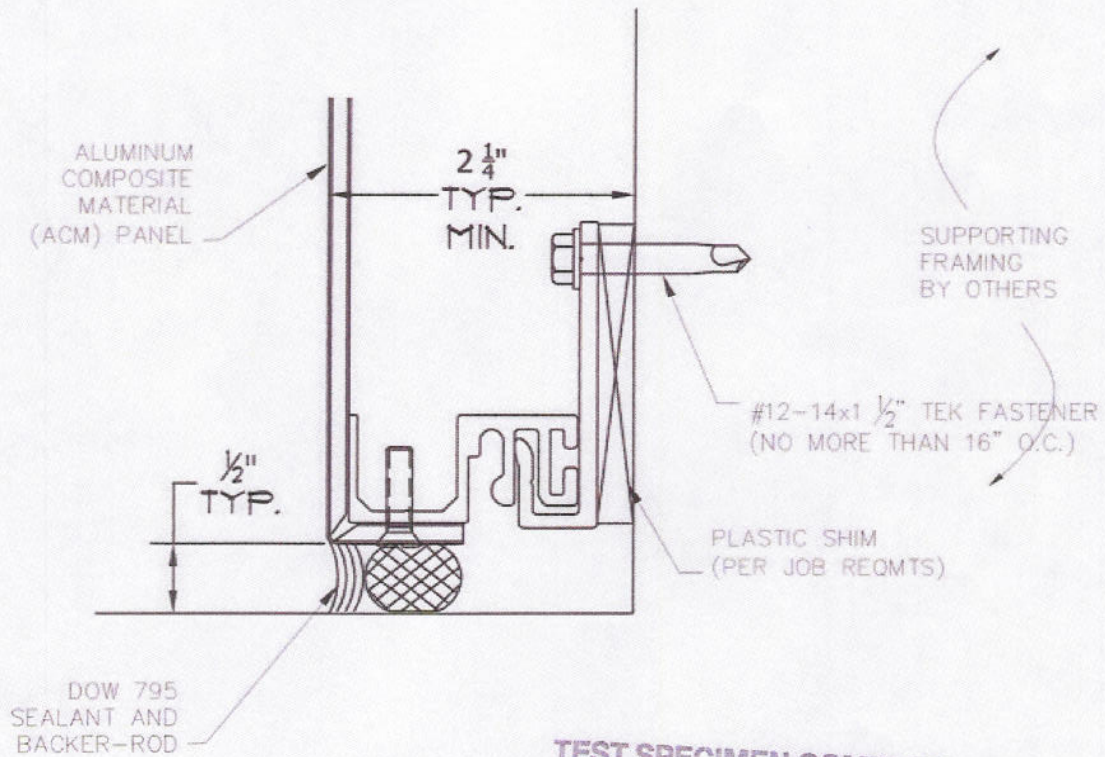
1
1A

SILL TERMINATION (WET SEAL)
SCALE: NONE

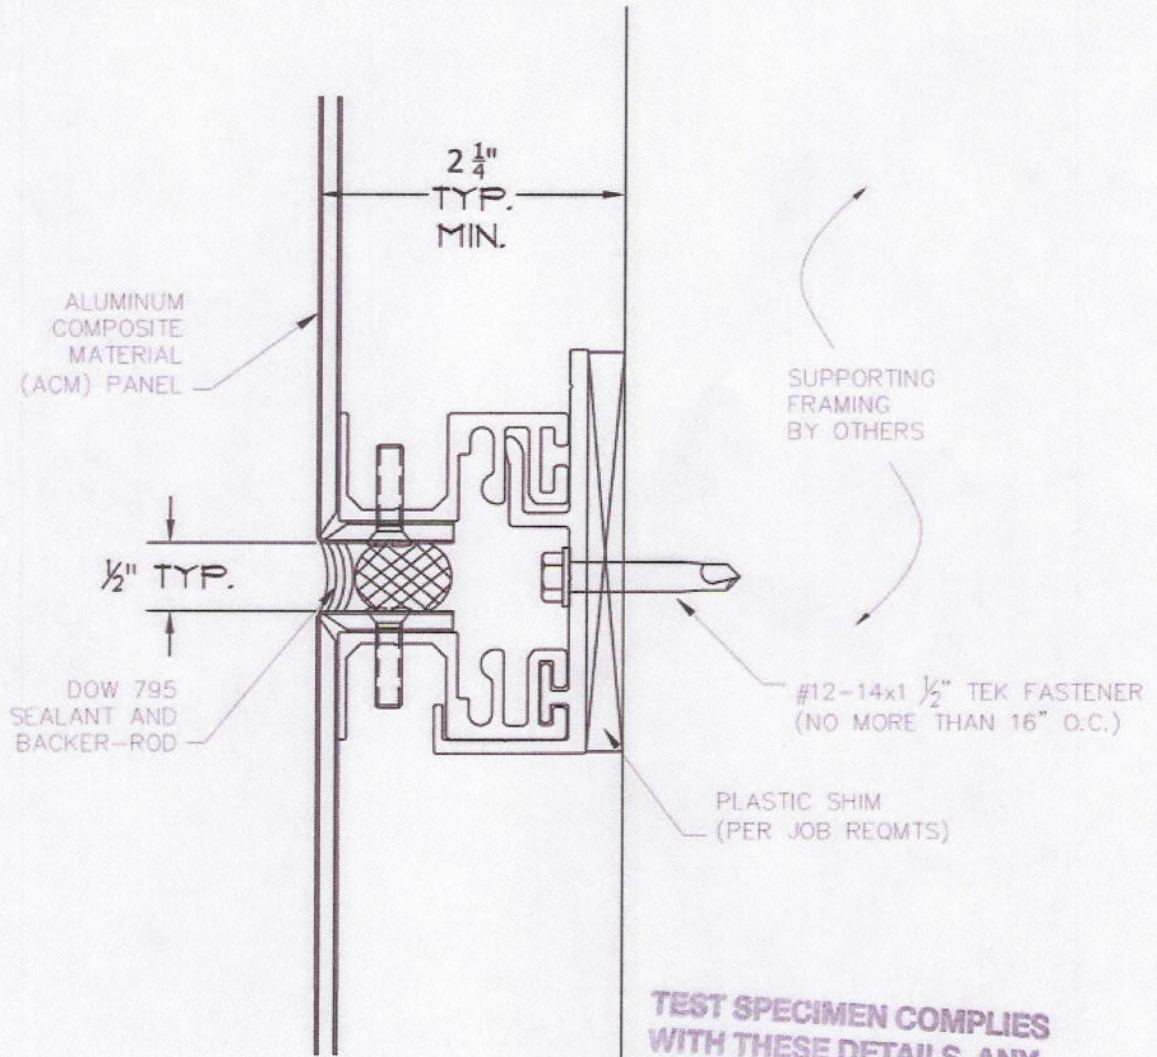
1
2A TYP. HORIZONTAL JT. (WET SEAL)
SCALE: NONE

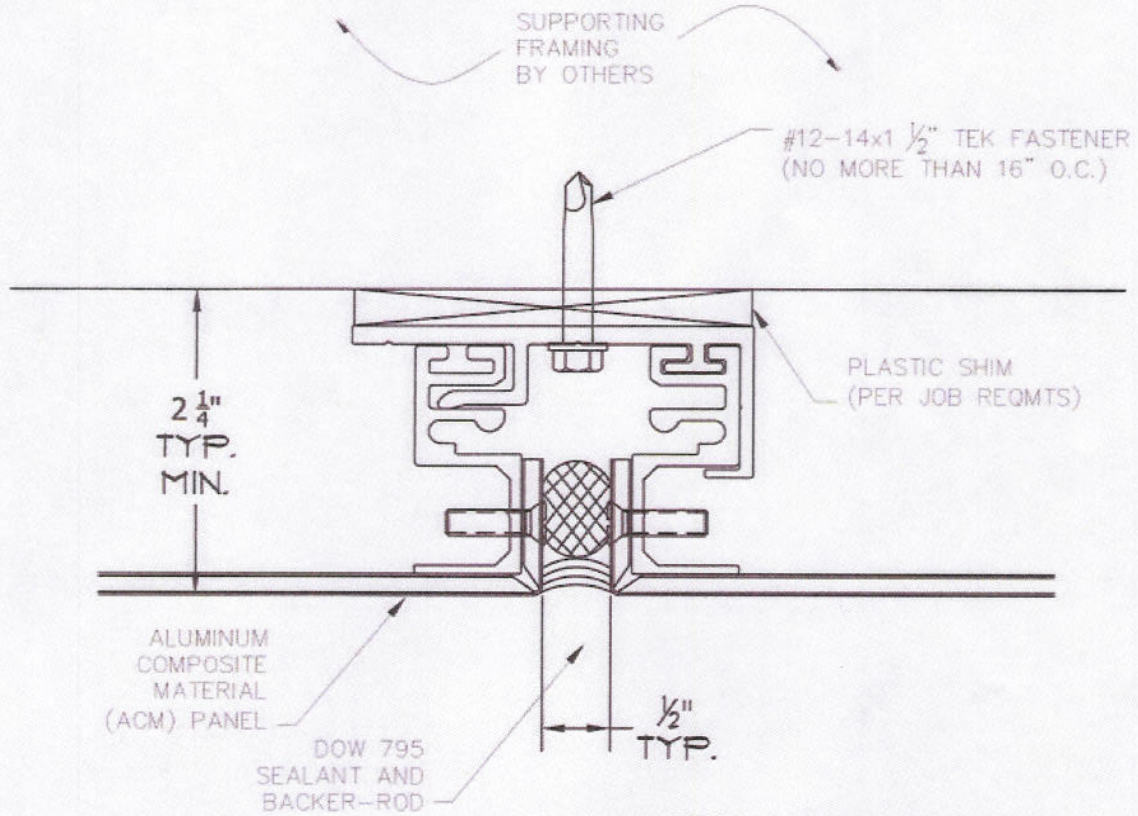
1
3A TYP. VERTICAL JT. (WET SEAL)
SCALE: NONE

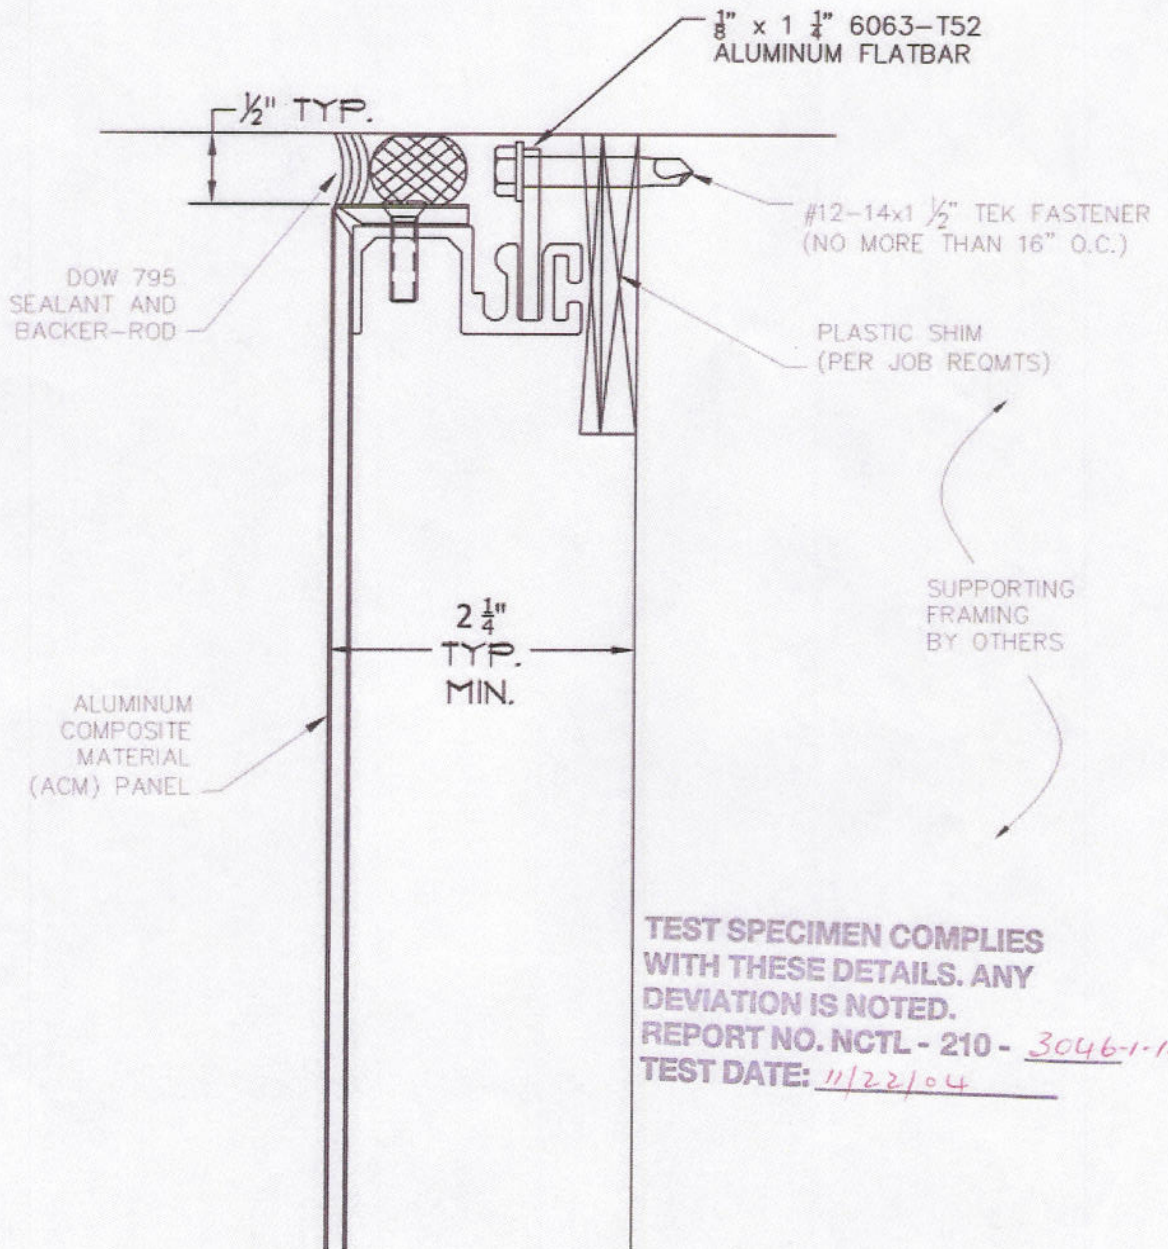
1
4A HEAD TERMINATION
SCALE: NONE

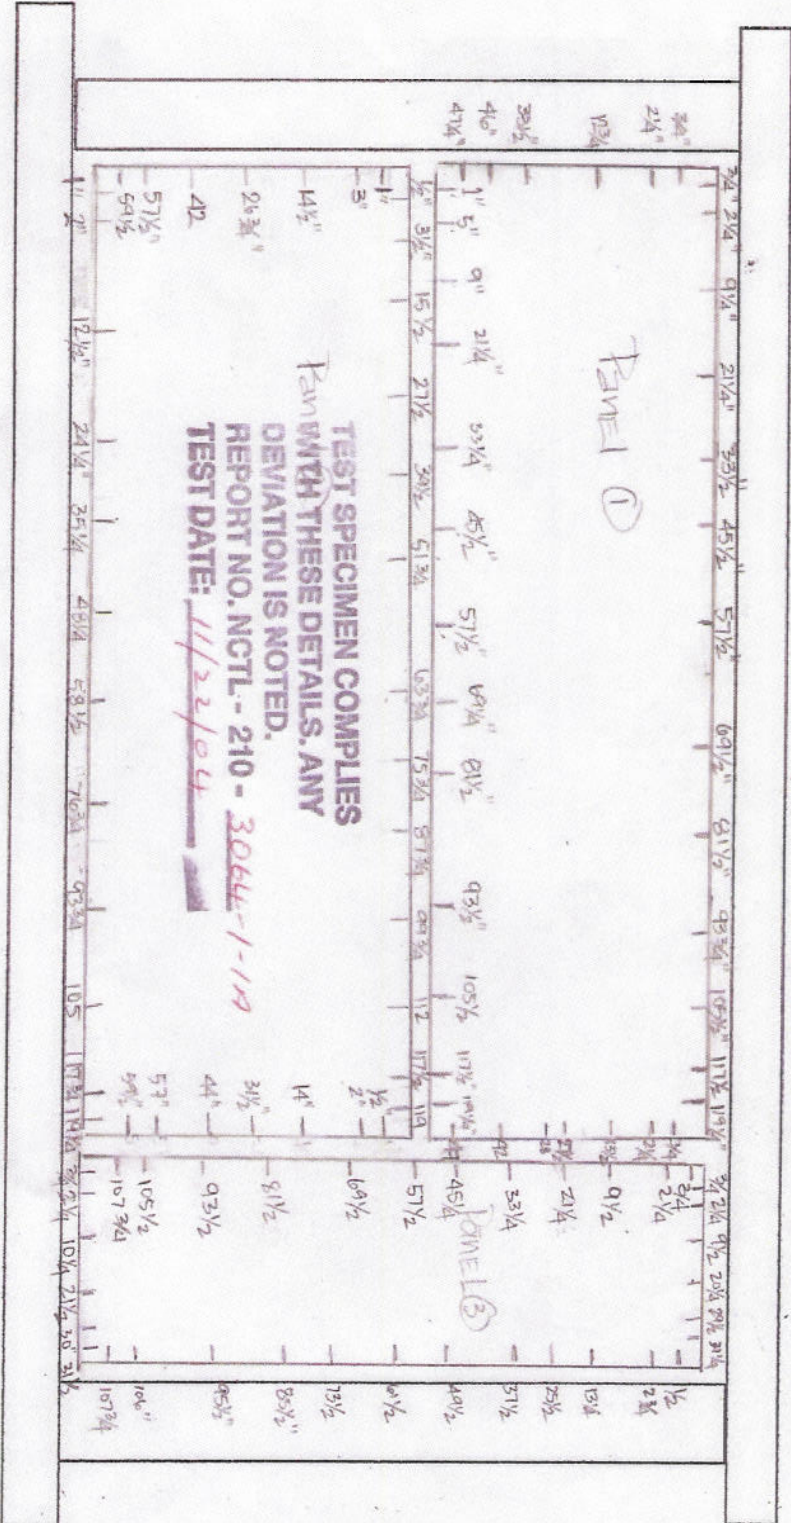
The test specimen was mounted to the test buck using fasteners at the locations shown. Surface mount specimens are measured from rough opening and flange mount specimens are measured from exterior dimensions.

8 X 3/4" P. F.H. Self Drill
 This fastens the aluminum rail to the panels

Back of Panel System

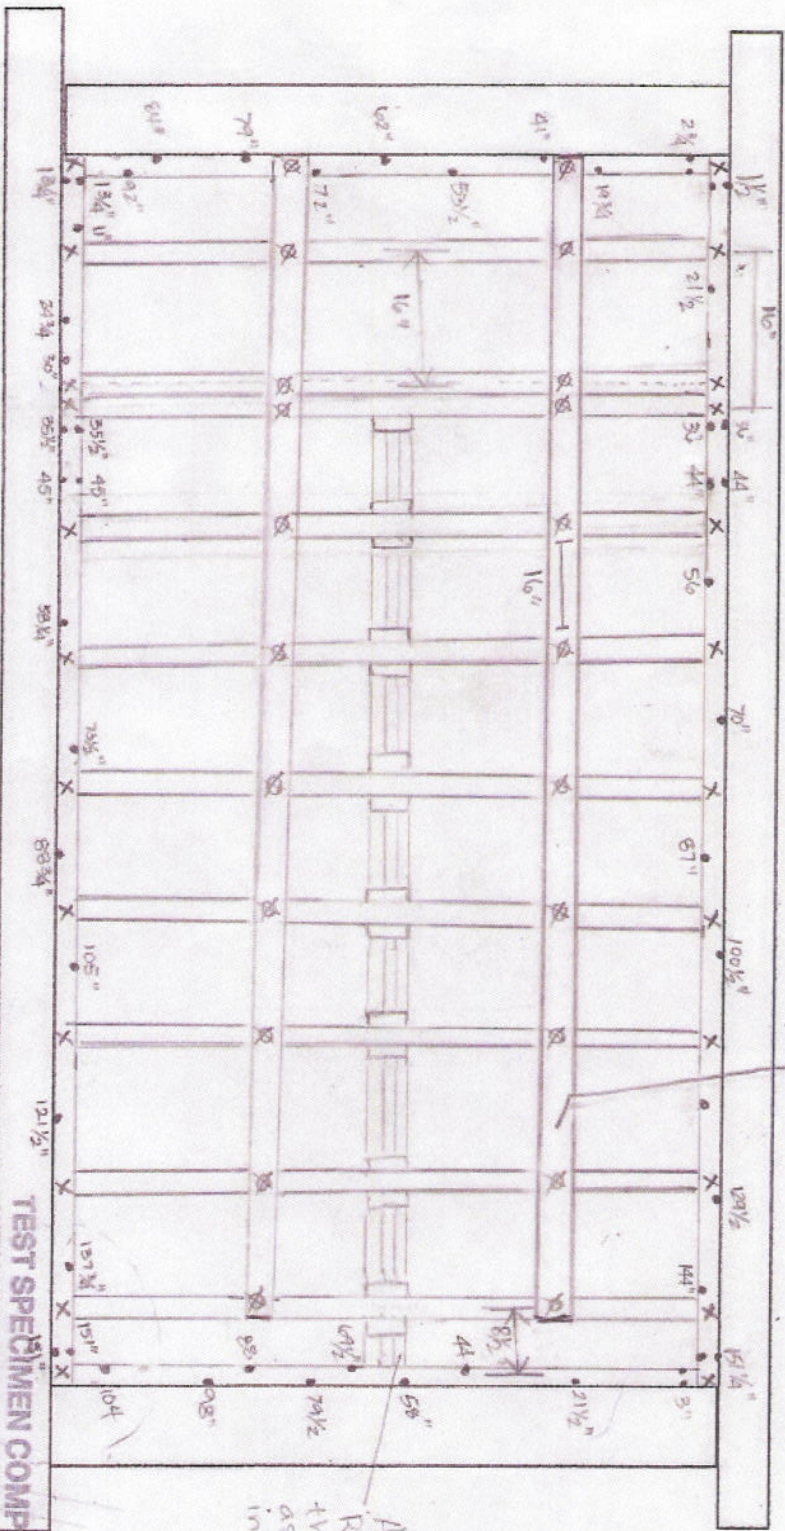
The test specimen was mounted to the test buck using fasteners at the locations shown. Surface mount specimens are measured from rough opening and flange mount specimens are measured from exterior dimensions.

• #12 x 1/2" T.S. Self Drilling fasteners Steel Studs to wood Buck
 X #12 x 1/2" T.S. Holds vertical & horizontal Steel Studs together

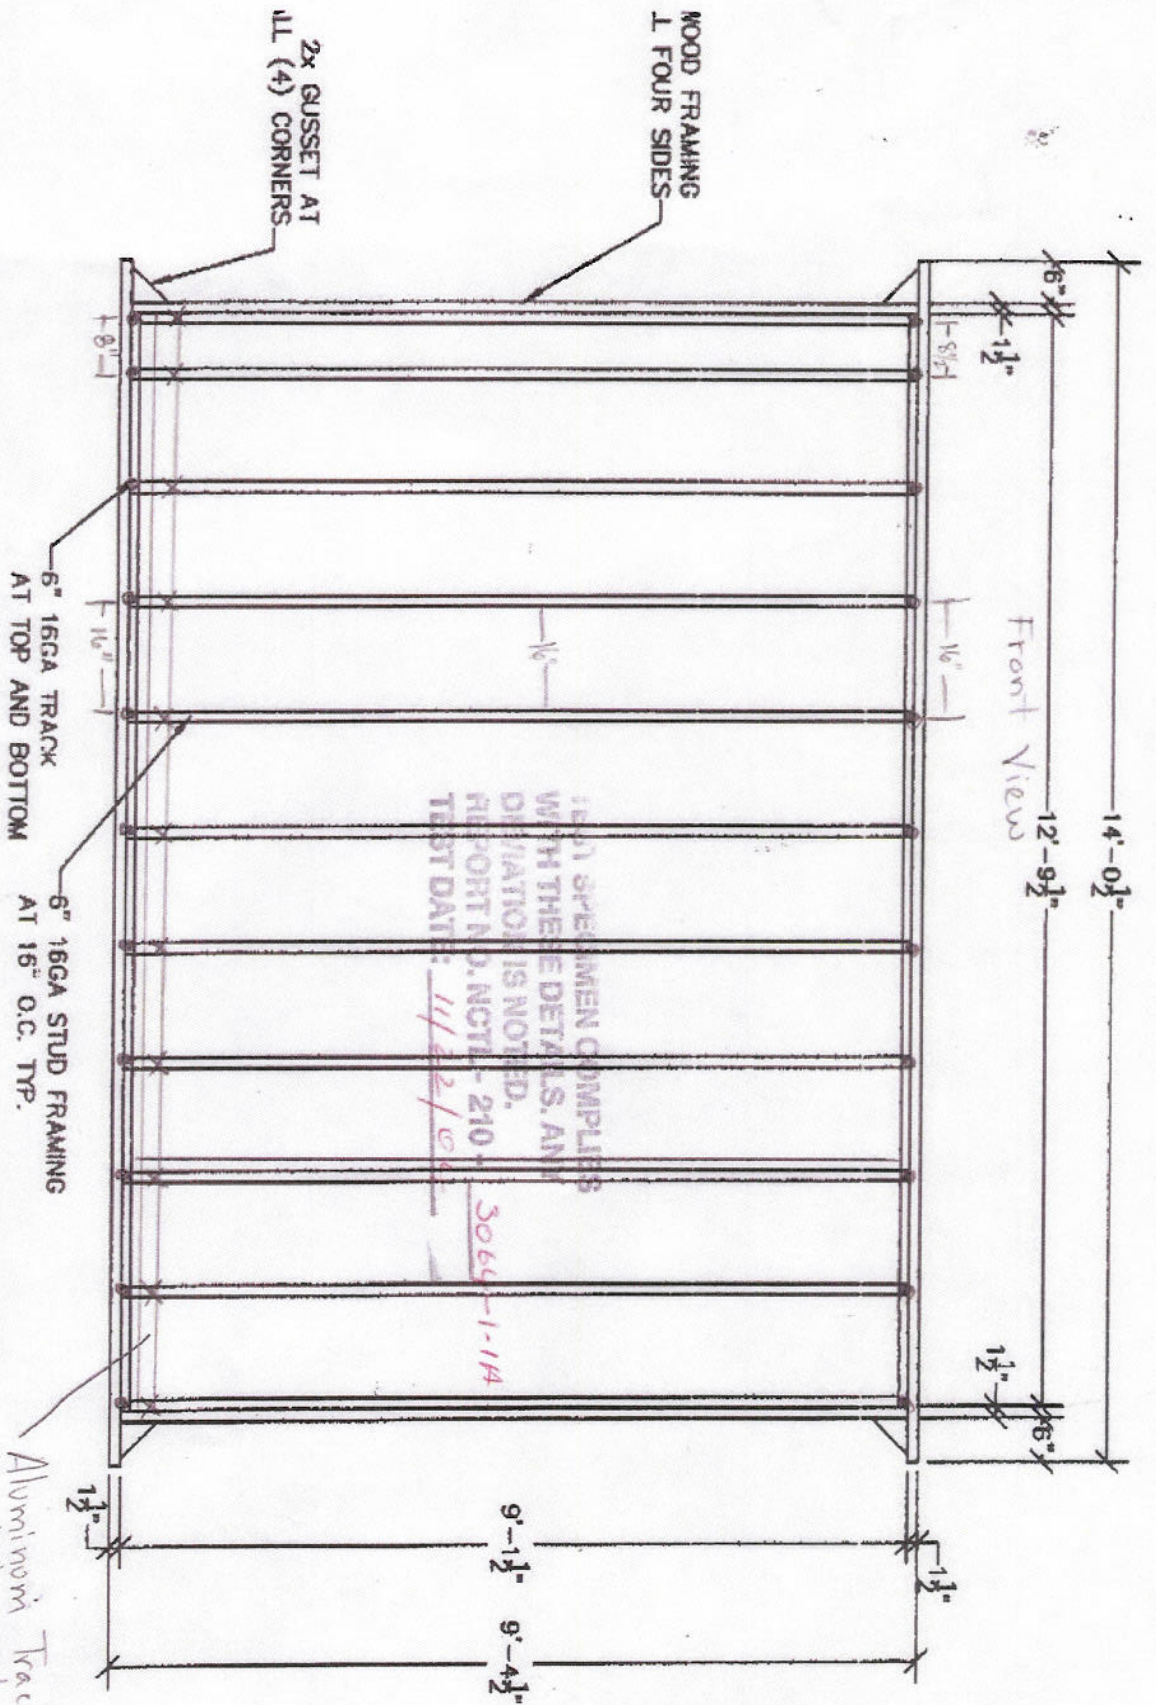
STRUCTURAL TEST BUCK LAYOUT

Aluminum Track or Interlock system were the panel bottom will sit on

FASTEN TRACK & OUTSIDE STUD TO 2x12" WOOD FRAMING WITH #12x1 1/2" TEK @ 16" O.C.

2"x12" WOOD FRAMING AT ALL FOUR SIDES

2x GUSSET AT ALL (4) CORNERS

FASTEN EACH STUD TO TRACK WITH #12x1" TEK FRONT & BACK

6" 16GA TRACK AT TOP AND BOTTOM

6" 16GA STUD FRAMING AT 16" O.C. TYP.

Main Frame Construction - The main frame was constructed from 16ga steel stud framing. The first stud was located 8" from left side and 16" on center thereafter. Each stud was fasten to the track at the top and bottom with # 12 x 1" Tek screw front and back. There were three (3) 4mm aluminum composite panels measuring Top panel 120.0" wide x 48.0" high. Bottom panel 120.0" wide x 60.0" high. Side panel 32.0" wide x 108.5". All caulk joints measured 1/2" wide. An Aluminum extrusion die # ALTP-1 measuring the full length of the sill was attached to each stud with # 12 x 1.5" Tex screws. Each panel had a 1.0" return. The top and bottom panels had an aluminum extrusion die # ALTP-3 attached to the return on all four sides with thirty nine (39) # 8 x .750 Phillips flat head self-drilling screws. The side panel had an aluminum extrusion die # ALTP-3 attached to the return on all four sides with thirty six (36) # 8 x .750 Phillips flat head self-drilling screws See drawing attached. Horizontal between top and bottom panels located on each stud there was a bracket measuring 3" x 3" die # ALTP-2 each bracket was attached to the stud with one (1) # 12 x 1.5" hex head screw. Vertical between top and bottom and side panels on the stud there was ten (10) brackets measuring 3" x 3" die # ALTP-2 located 4.0", 17.5", 32.5", 44.75", 51.25", 65.75", 81.25", 92.0", 103.5" and 106.0" measuring from top to bottom each bracket was attached to the stud with one (1) # 12 x 1.5" hex head screw all the panels interlock into the brackets. The head and both sides were attached to the studs with .125" x 1.25" 6063-T5 aluminum flat bar with # 12 X 1.5" Tex screws located both sides 4.0", 14.0", 27.0", 38.5", 50.5", 62.5", 74.5", 86.5", 97.0" and 106.0" measuring from top to bottom. Located in the head 9.0", 27.5", 41.5", 58.75", 83.25", 110.75", 126.75", 133.75", 142.25", 150.25" and 161.25" measuring from left to right.

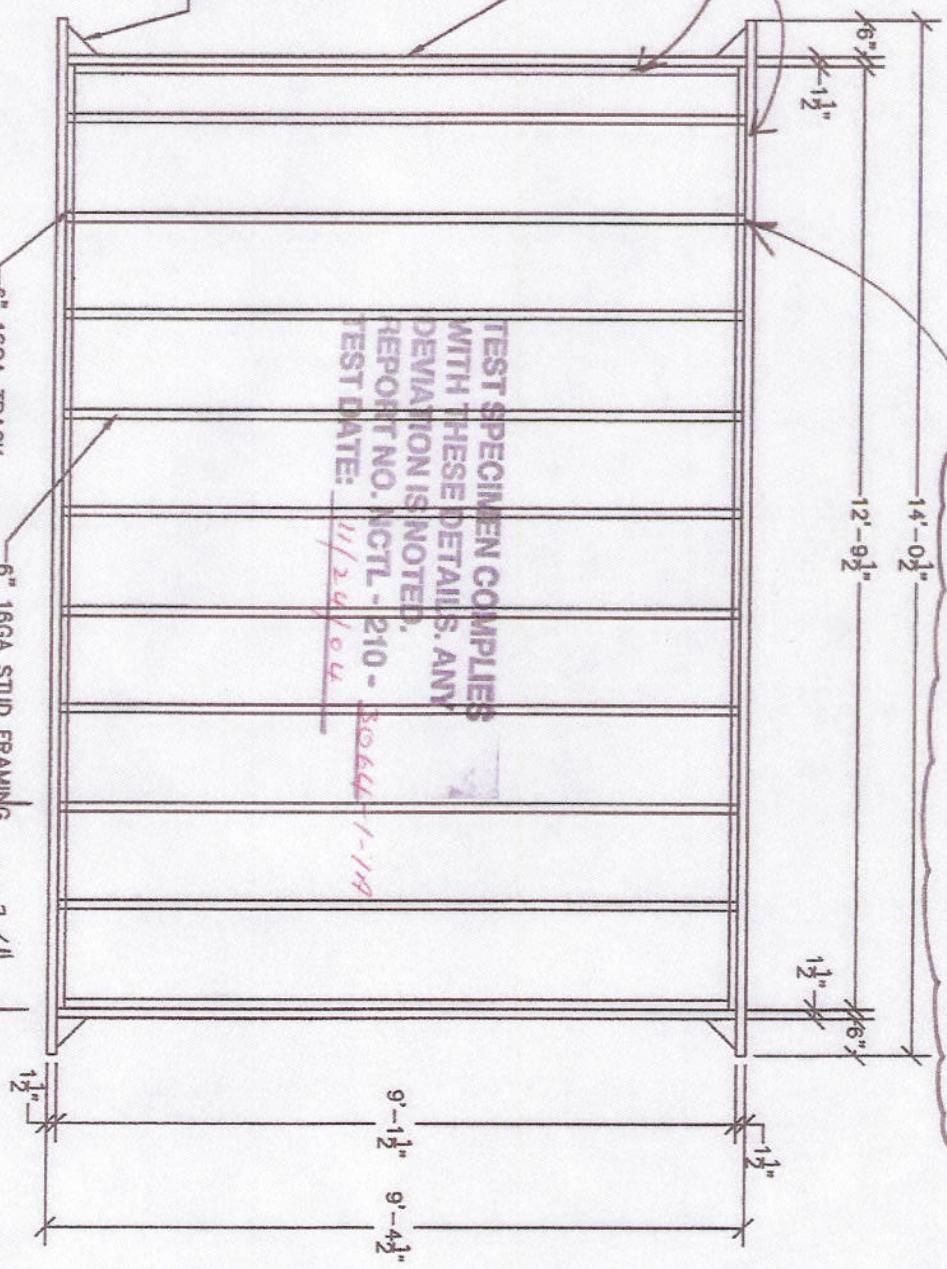
ALTECH PANEL SYSTEMS TEST BUCKS

FACE OF 2X
